TN no. N-1496

**title:** INVESTIGATION OF SPRAY-APPLIED  
POLYURETHANE FOAM ROOFING SYSTEMS - I

**date:** July 1977

## CIVIL ENGINEERING LABORATORY

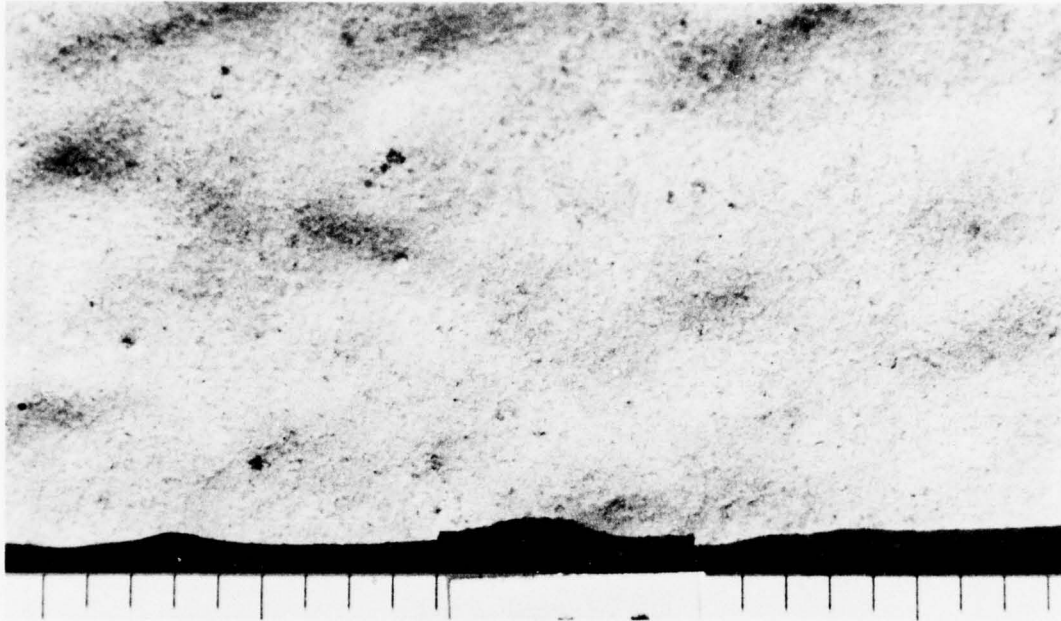
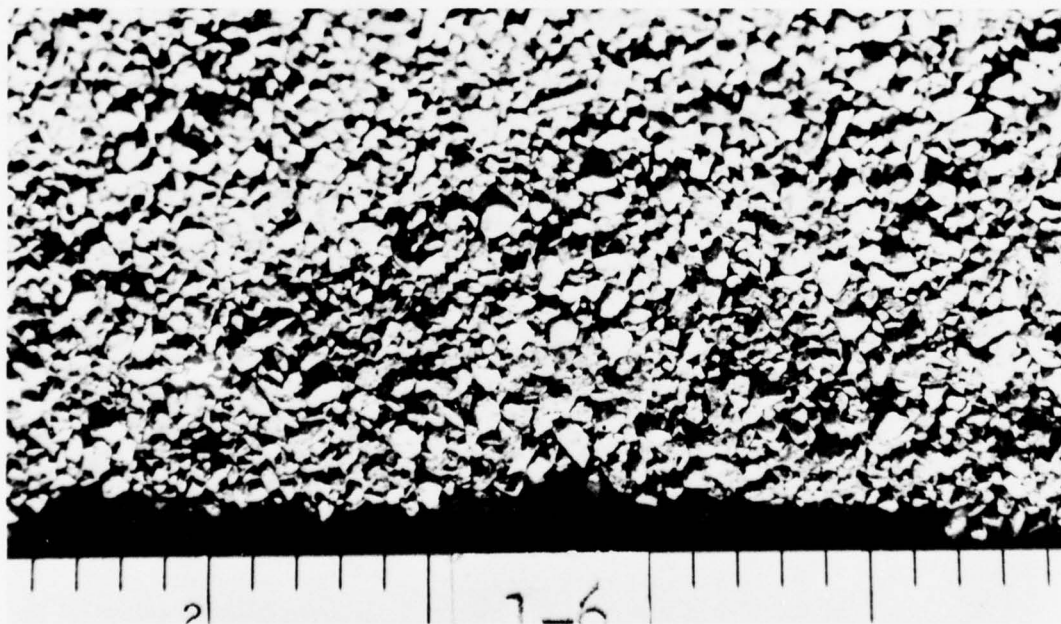
Figure 8. Effects of roofing granules on dirt retention.

(a) Dirt retention on catalyzed silicone rubber (System 1) after 18 months of exposure.

(b) Practically no dirt retention visible on catalyzed silicone rubber with granules (System 1G) after 18 months of exposure.

1. Granules sprinkled into the wet topcoat (System 1G) provide additional protection against mechanical damage (including impact), weathering, bird pecking, and they also improve general appearance.

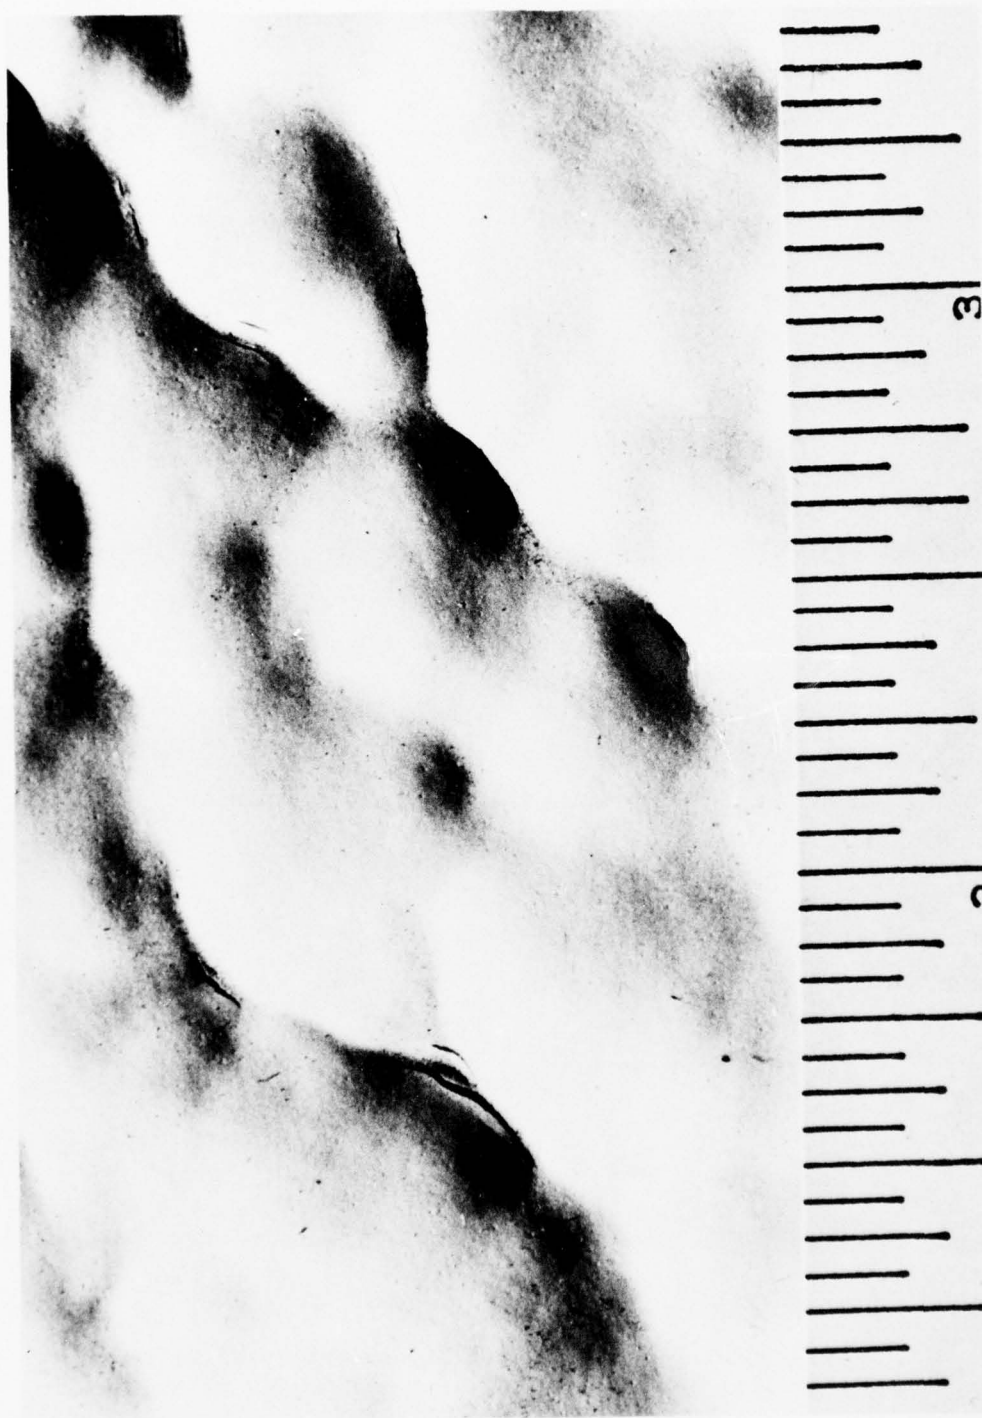
Systems 2 and 2A - Moisture-Curing Silicone Rubber. These systems are similar to System 1 except that this silicone cures by reacting with moisture in the air and thus does not require special spraying equipment to apply. After 1 year of exposure at Pickel Meadows, the performance of System 2 is rated as excellent. Figure 9 shows typical checking or cracking of the coating which occurred in depressions on the Port Hueneme and China Lake panels before these panels were exposed; it has not become more severe after two years of exposure. The performance of the systems at these two locations was rated as very good for their respective exposure periods.

Figure 9. Checking or cracking of moisture-curing silicone rubber coating (System 2).  
(China Lake; before exposure.)

System 2A panels were prepared after the checking or cracking was noted on System 2. Performance of System 2A was rated as excellent after 6 months of exposure at China Lake and Pickel Meadows and 1 year at Port Hueneme. Like the System 1 silicone, the System 2 moisture-curing silicone rubber also retains dirt; the white topcoat attains a dirty gray appearance on exposure which has not affected its performance.

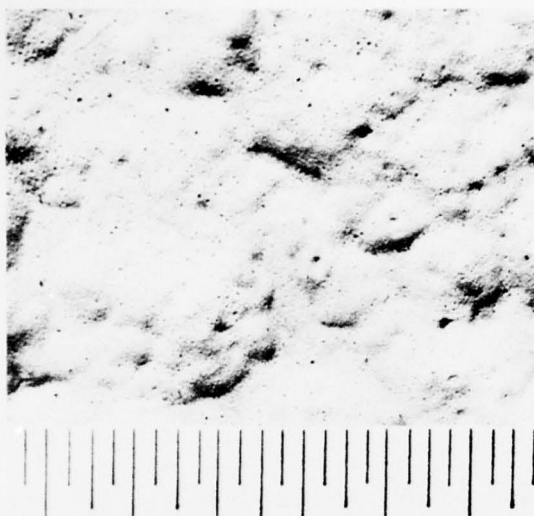
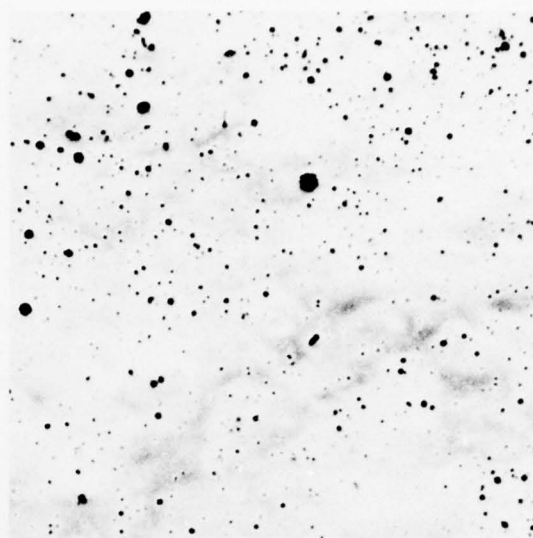
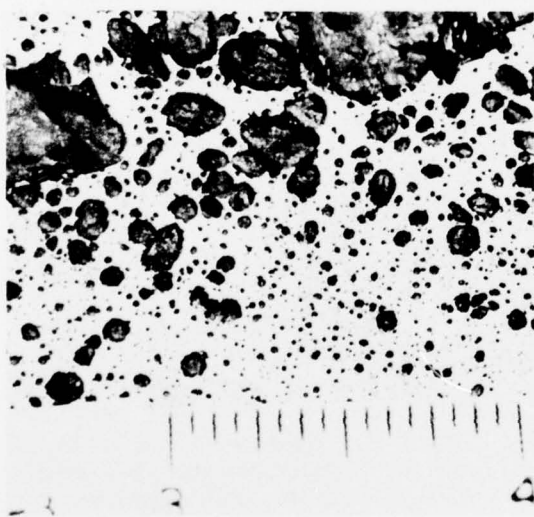
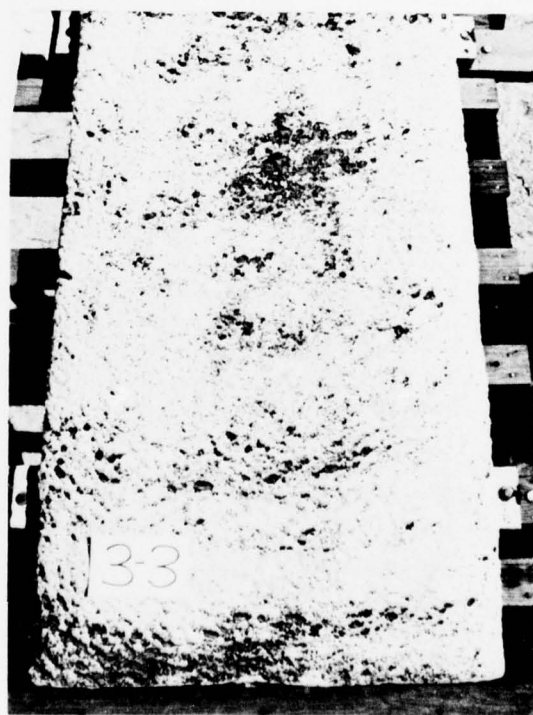
System 3 - Catalyzed Butyl-Hypalon. The dense solvent pinholes in the topcoat of this system were the focal points for incipient deterioration. The topcoat tended to lose adhesion and curl back from the base coat in the general area of the pinhole. The photomicrographs in Figure 10 show this quite dramatically for the panel exposed at China Lake for various periods of weathering. The topcoat of hypalon gradually peeled, exposing the butyl base coat which then deteriorated and exposed the foam directly to the weather. The most rapid deterioration of the system occurred at China Lake where it had failed by the end of the first year of exposure. Performance of System 3 was almost as poor at the Pickel Meadows site, where the system was also nearing failure following one year of exposure. The exposure at Port Hueneme was not quite as severe and the system was rated as good to poor after 2 years of weathering.

Figure 10. Progressive degradation of catalyzed butyl-hypalon (System 3) after various periods of weathering at China Lake.

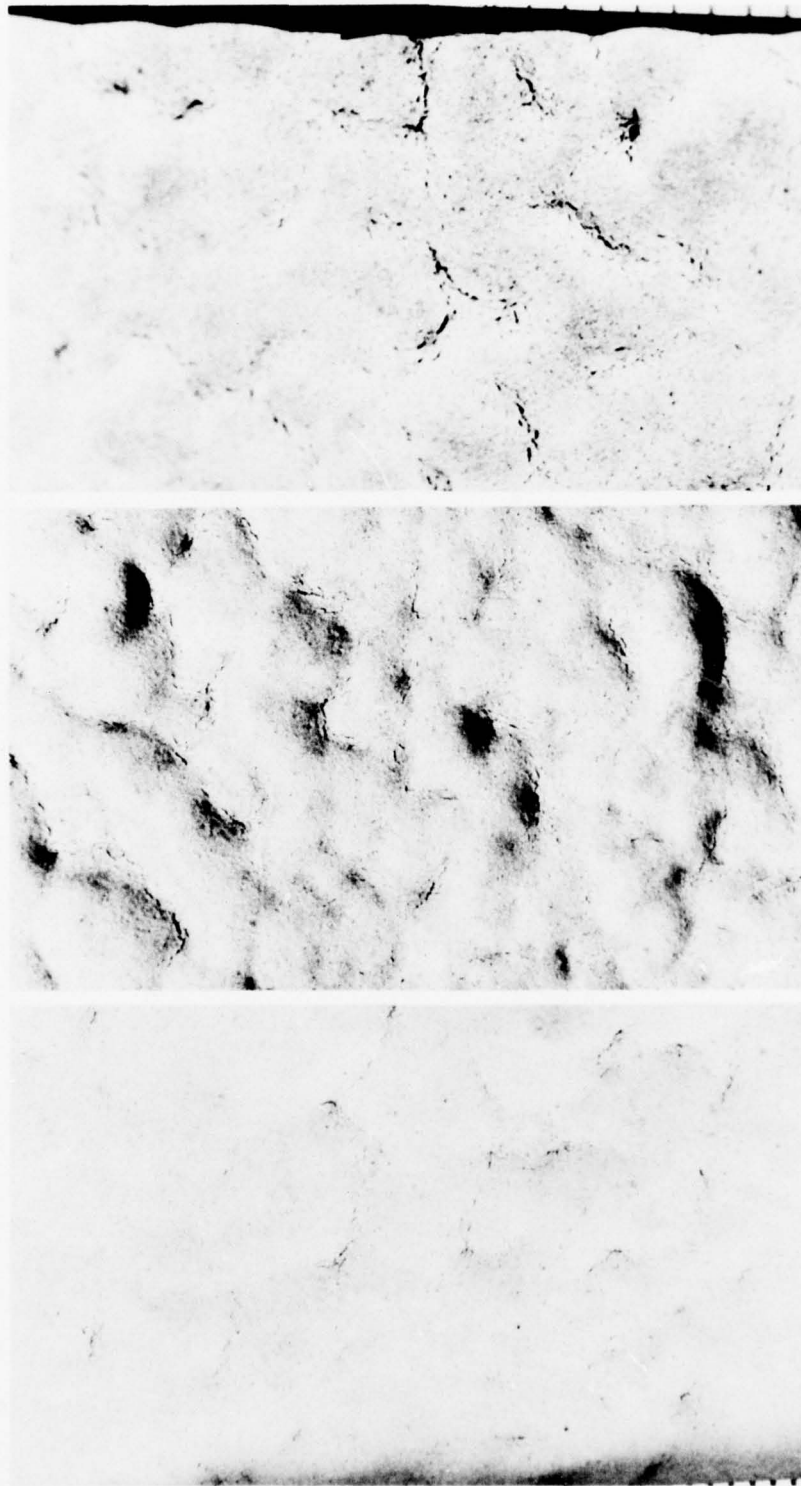
Systems 6 and 6A - Elastomeric Acrylic Emulsion. System 6 was a two-coat application of this coating, while System 6A was a single-coat application. The single-coat application on the Port Hueneme panel resulted in very light checking in depressions shortly after it was placed on exposure. As shown in Figure 11, this checking has not increased during exposure. Similar checking was not found on panels of System 6A exposed at the other sites. Although the performance of the System 6A panel exposed at Port Hueneme was rated as very good after two years of exposure, all other panels of both Systems 6 and 6A were rated as excellent after exposures of 1 to 2 years. As with the silicones, dirt and soil are not easily washed from the surface of this coating; thus, it has a dirty gray appearance but this does not appear to affect its performance.

Figure 11. Light checking in depressed areas of System 6A, 1 coat acrylic elastomer after various periods of weathering at Port Hueneme.

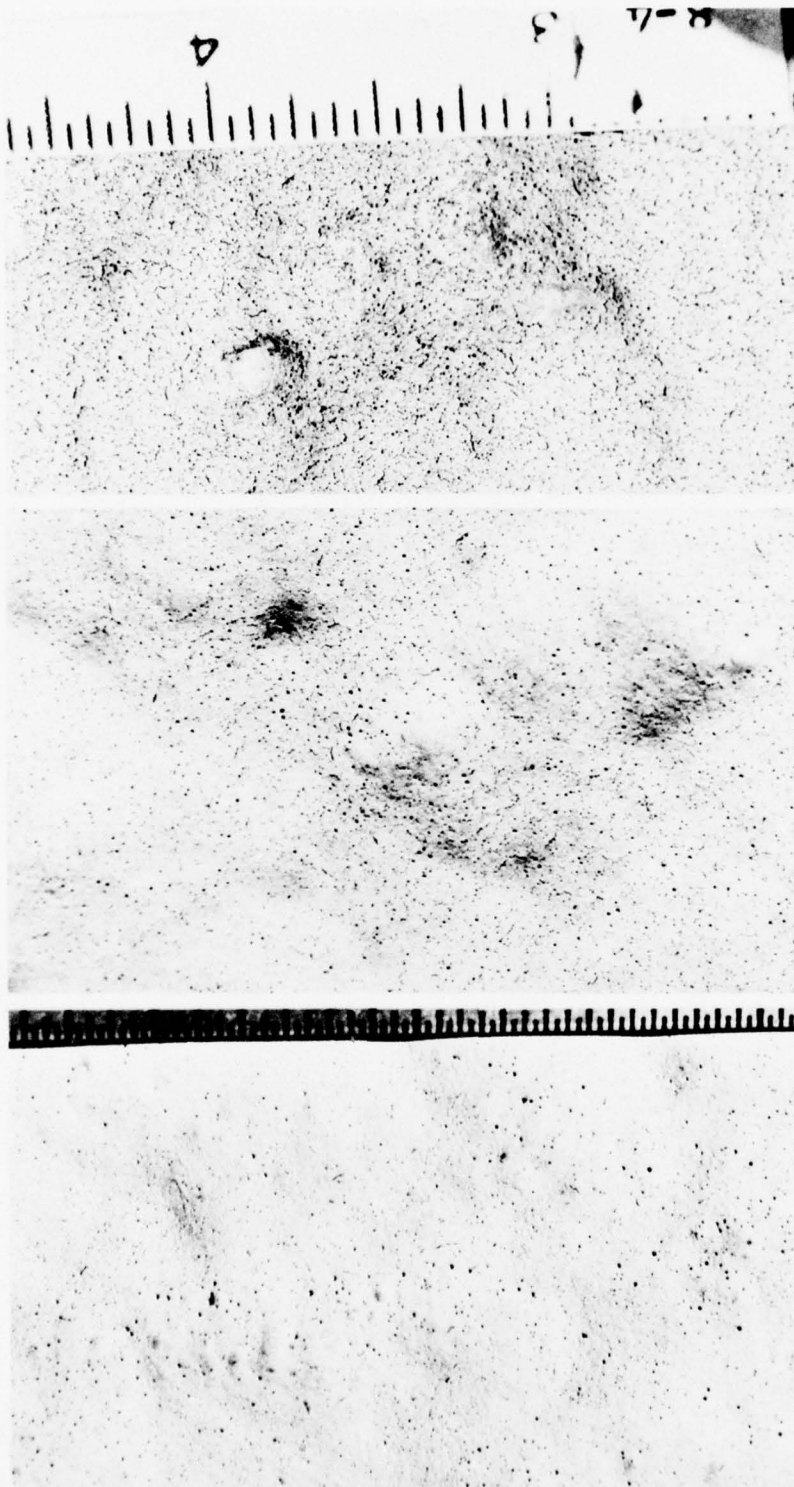
Systems 8 and 8A - Aluminum-Pigmented Catalyzed Butyl. The coating of System 8 was slightly damaged during transit to the test sites, and System 8A was prepared to supplement System 8. Very dense shallow solvent pinholes were characteristic of the aluminum-pigmented butyl of System 8. There were, however, only scattered pinholes in System 8A, presumably because of better application procedures. Pinholes in System 8 became more evident after weathering, particularly at Port Hueneme and Pickel Meadows, as indicated in Figure 12. As with System 3, the solvent pinholes appear to be the focal point for coating deterioration. However, this system is still performing relatively well after 1 to 2 years of exposure at the three sites. Its performance was rated as good at Pickel Meadows (1 year), very good at Port Hueneme (2 years), and excellent at China Lake (1 year). At report time, System 8A had been exposed for only 6 months at Pickel Meadows and China Lake and for only 1 year at Port Hueneme; performance of all three panels was rated as excellent.

Figure 12. Progressive development of pinholes with weathering of aluminum-pigmented catalyzed butyl (System 8) at Pickel Meadows.

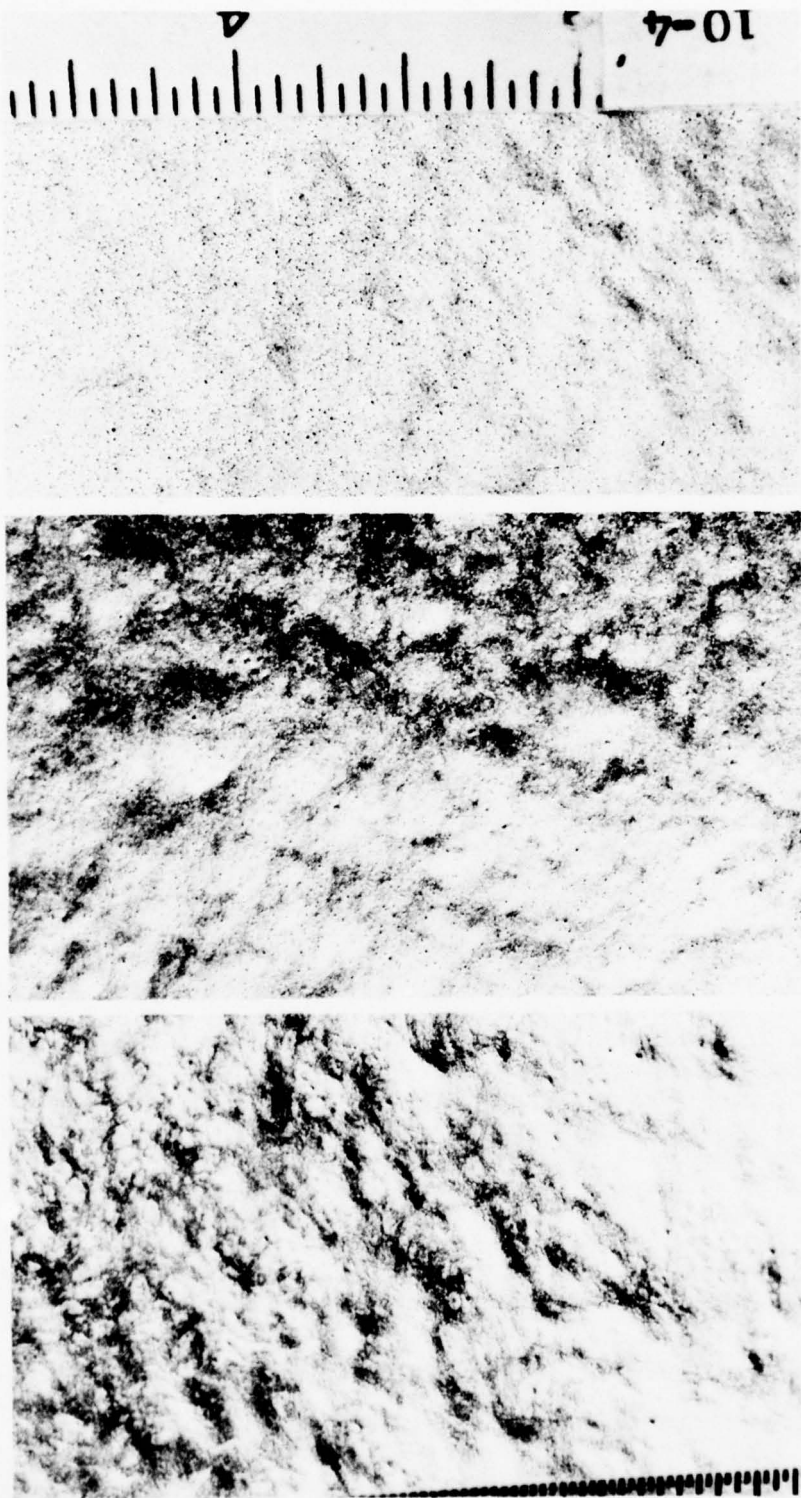
System 10 - Aluminum-Pigmented Catalyzed Urethane. As mentioned earlier, this system tended to flow into low areas on the panel when applied and to attain a much greater thickness at these points. As a result, the coating was somewhat thinner on the higher areas of foam. To date this has not affected its performance, but incipient deterioration may be occurring as indicated in Figure 13 by the increasing number of black specks becoming evident with additional exposure. Its performance was rated as excellent after 2 years at Port Hueneme and excellent after 1 year at the other two sites.

Figure 13. Progressive development of black specks in aluminum pigmented catalyzed urethane (System 10) at Pickel Meadows.

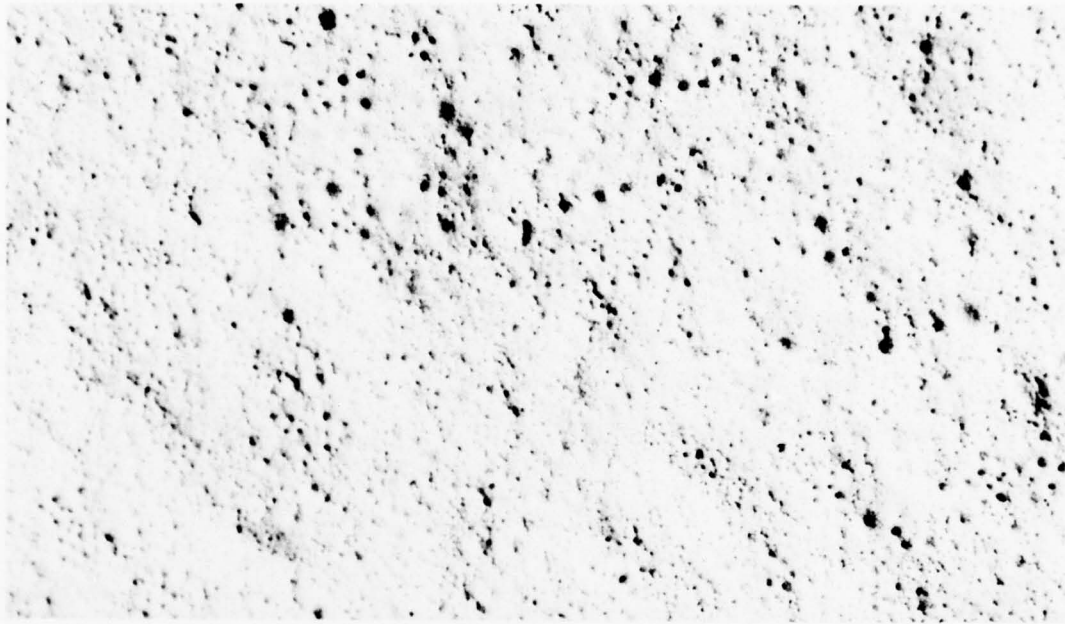
Figure 14. Differences in surface texture between Systems 12 and 12A, both hypalon mastic.

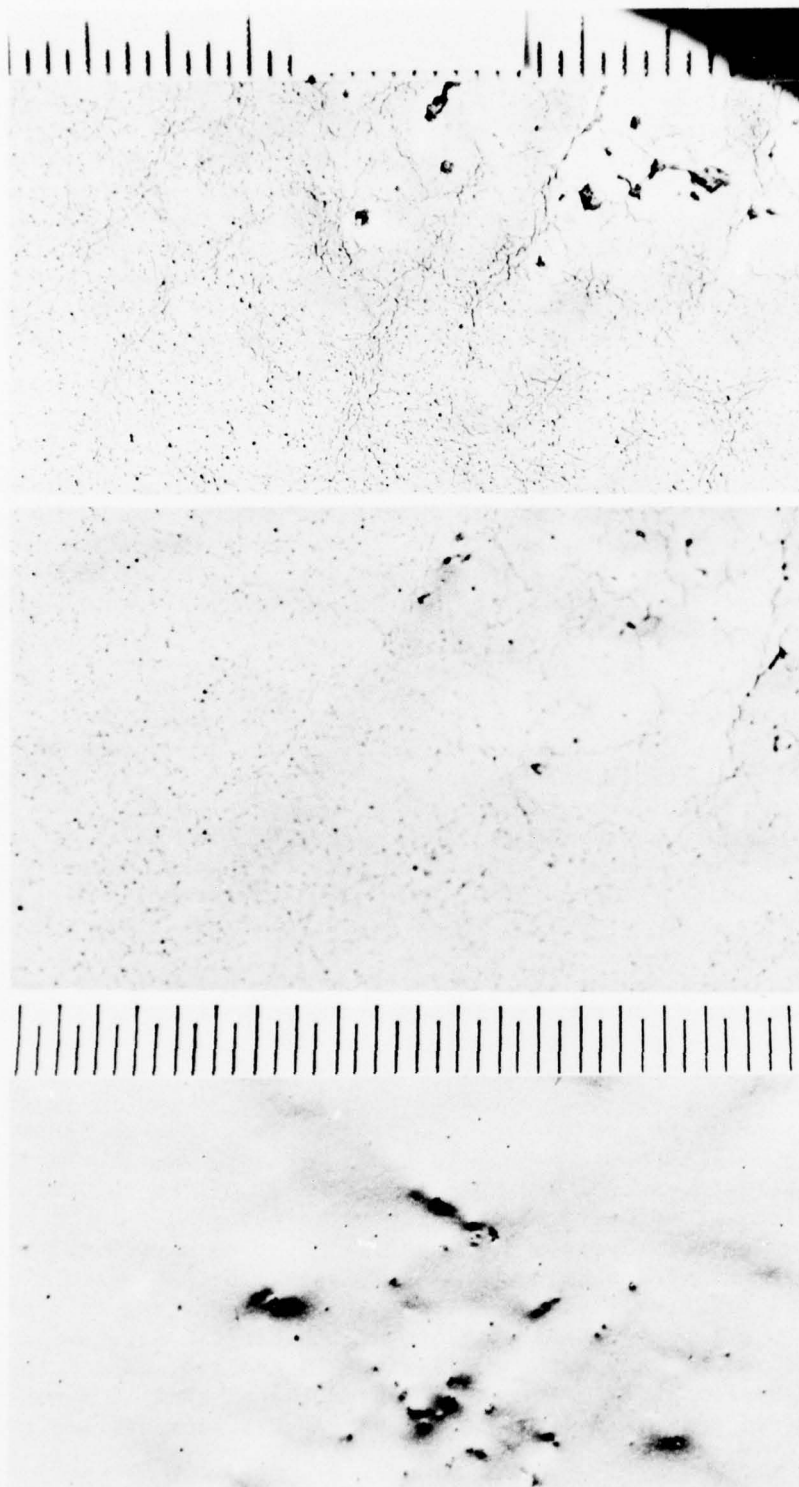
Systems 14 and 14A - Moisture-Curing Urethane Elastomer. Great difficulty was encountered with the application of System 14. As a result, System 14A was applied under the direction of the manufacturer's representative. As with Systems 12 and 12A, System 14 had dense solvent pinholes up to 1/16-inch in diameter all over the panel, while System 14A had very few pinholes. Although these pinholes contributed to deterioration, they were not the only cause. The coating tends to chalk very heavily and shows severe checking and flaking, all of which are attributed to regression of the urethane elastomer and all of which contribute to progressive deterioration such as shown in Figure 16. After 1 to 1-1/2 years exposure, the performance of this system is rated as poor to failed. System 14A however, although chalking heavily, is performing better, and after 6 months to 1 year of exposure, its performance is rated as excellent at all three sites.

Figure 16. Progressive deterioration of moisture-curing urethane (System 14) after various periods of exposure at Pickel Meadows.

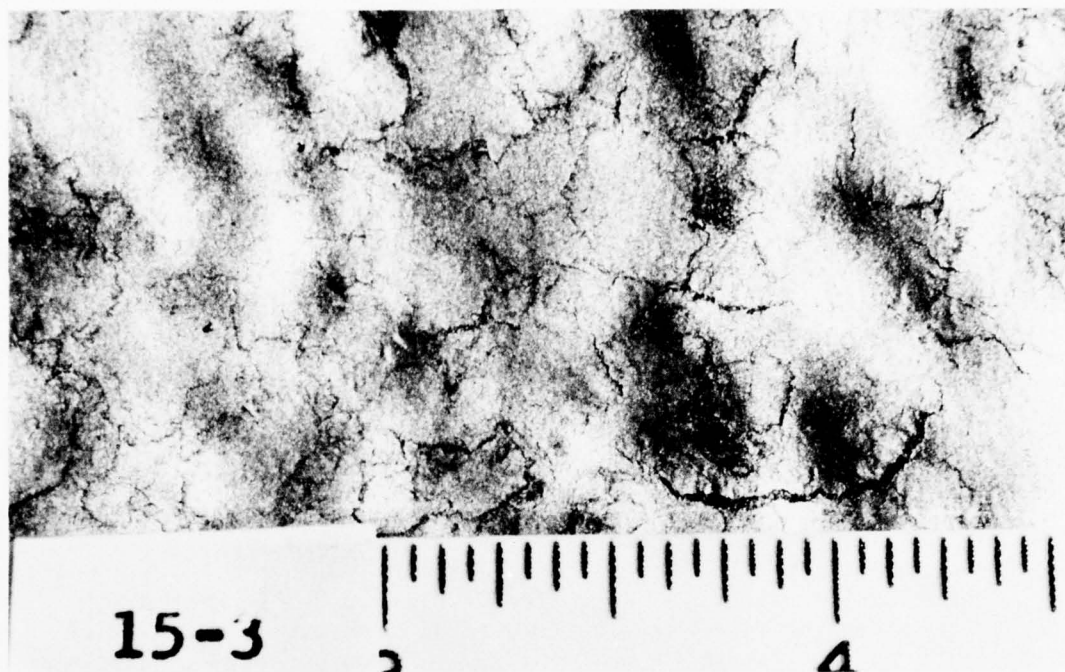
System 15 — Fibrated Aluminum-Asphalt. Asphalt and aluminum-asphalt coatings have been widely used over foam in spite of poor performances in the field. System 15, a high quality fibrated-aluminum asphalt, was included as a control. After only 6 months of exposure at the China Lake and Pickel Meadows sites, light deterioration in the form of alligatoring was noted, as shown in Figure 17. In addition, this system was the only coating investigated that was damaged by hail at the Pickel Meadows site; hail damage can be seen in Figure 18. However, neither of these forms of deterioration was severe and this system was rated as very good at both China Lake and Pickel Meadows after 6 months of exposure. System 15 was performing better at Port Hueneme and was rated as excellent after 12 months in a marine atmosphere.

Figure 17. Alligatoring of aluminum-asphalt (System 15) after 6 months at China Lake.

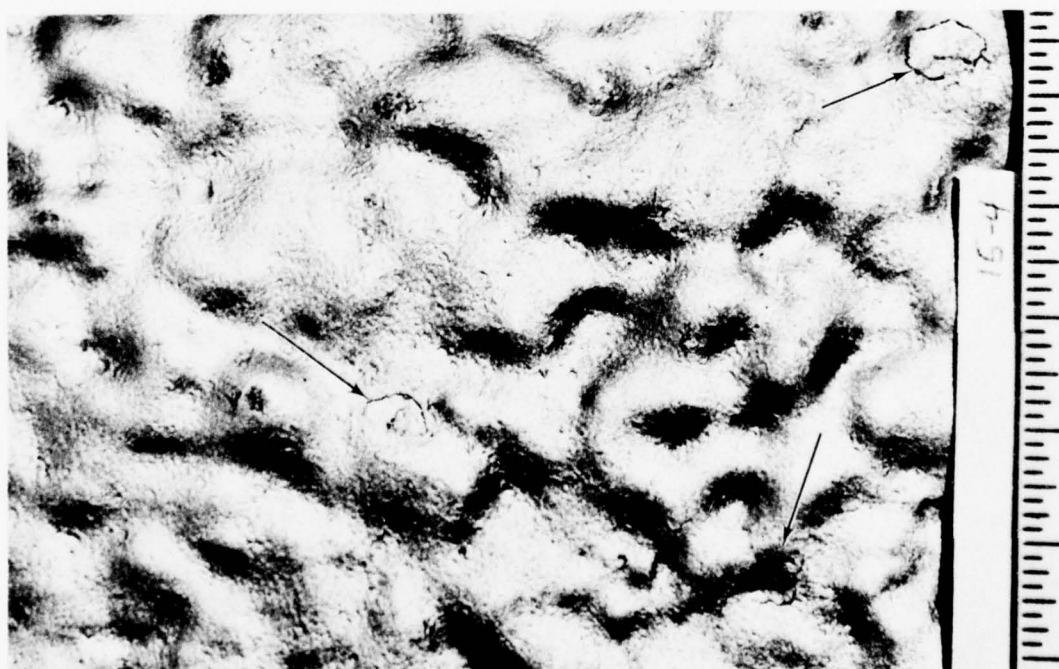
Figure 18. Hail damage in aluminum-asphalt (System 15) after 6 months at Pickel Meadows.
